Elderly people and fall hazards in the historical centre of Santiago de Chile. Assessment and barrier-removal proposals for a better quality of life

This article identifies fall hazards for elderly people in the public space of the historical centre of Santiago de Chile. It does so by defining barriers and surveying their presence in the selected public spaces and streets. It also records the perception of elderly people who use this space or have ceased to do so due to the risks they have to run. The results will serve as the basis for a proposal of measures for overcoming these barriers, thus raising the quality of life for this age group and all users of the city.

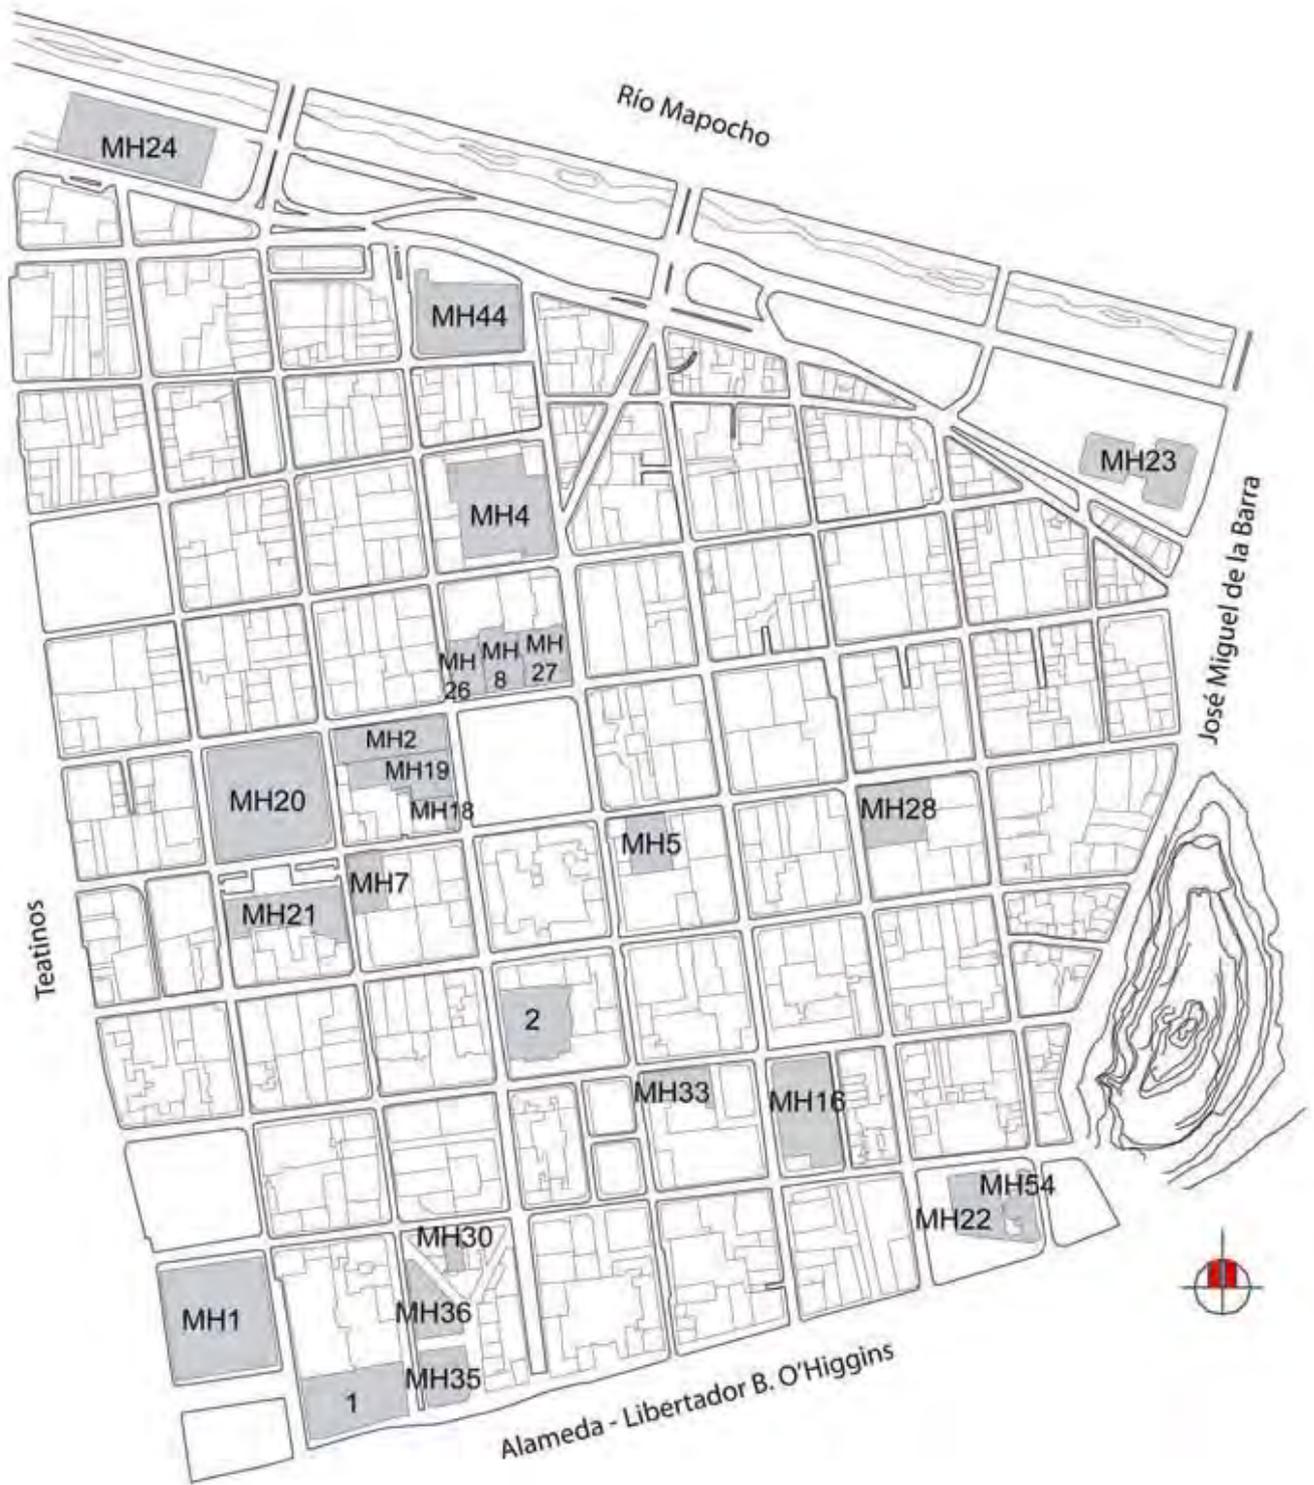
Figure 3. Location of important buildings.

A total sample of 26 buildings was chosen; 24 of them are historical sights set in the study area, with a big impact on the surrounding area and a large crowd-attracting potential (taken from the official record of the Local Byelaw of the Municipality of Santiago), then tagging on the head offices of two major banks *Banco del Estado* and *Banco de Chile*, both housed in listed buildings (Fig. 3).

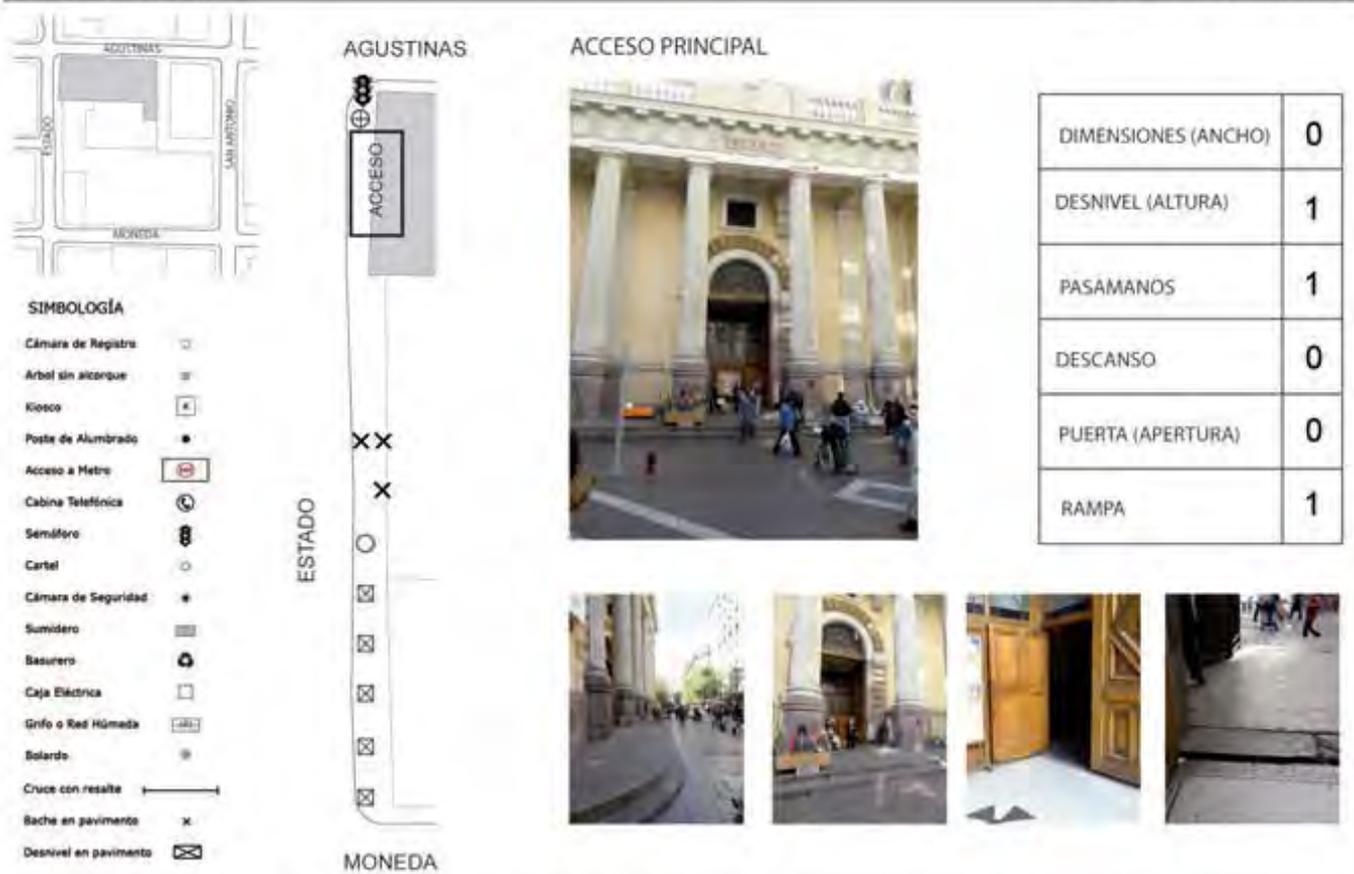
Figura 9. Important building study form.

A form was designed for field recording, showing the elevation of the main entrance to the building or metro and the state of the pavement of the block where it stands. The form therefore consists of a plan view with the corresponding part of the block, recording the barriers using the same symbols as for the study of thoroughfares; smaller scale location plan, photographs and a binary recording chart of the problem found.

A table was therefore drawn up with the abovementioned parameters, involving a binary analysis of 0 when there is no risk or problems and 1 when there is at least one problem. (Fig. 9) (Fig. 10)
